# Manhole Inspection Summary

Manhole # S11II\_007MH

**Location** Address: **REAR 1906 ELLAMONT ST**

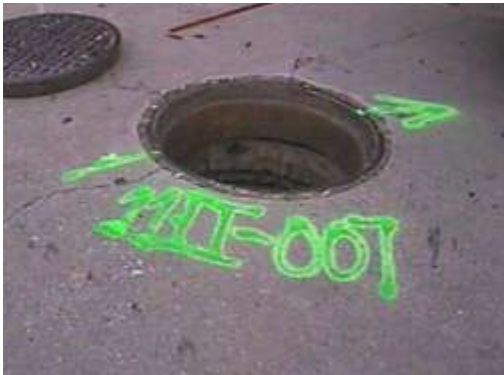
Location View

FRAME OFFSET

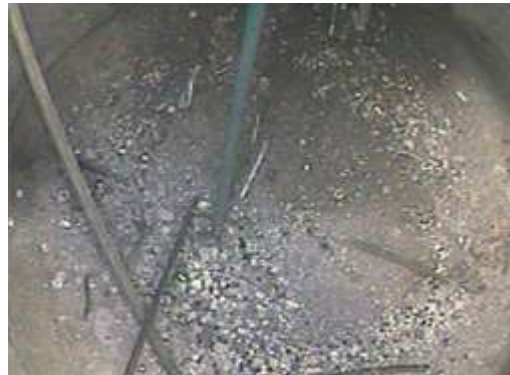
Top View

UNKNOWN PIPE OR CONNECTION IN LINE

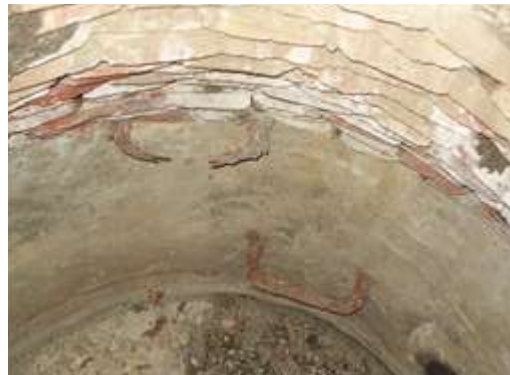
Defect 1

**Steps** Count: **2** Missing: **0** ☒ **Corroded**

CORRODED STEPS

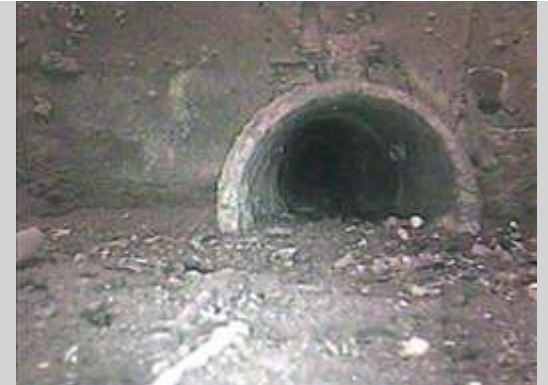
12 O'Clock Outflow

8 in. Circular Gravity Sewer  
Pipe Out @ 12 O'Clock

Pipe Height: (in.) Direct  
Pipe Material: **Clay** ☐ Pipe Lined  
Invert Depth: **6.31** (ft.) Flow Characteristics: **None**  
Deposits: ☐ None ☐ Mud ☐ Sludge ☒ **Debris** ☐ Grease  
Silt Depth: **1** (in.) Deposits Extent: **Light**  
Infiltration: **None** Pipe Seal Cond: **Sound**

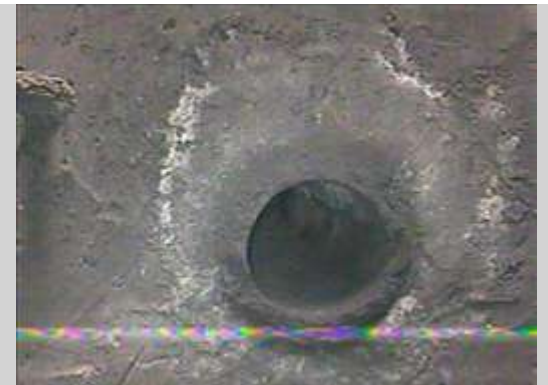
6 O'Clock Inflow

8 in. Circular Gravity Sewer  
Pipe In @ 6 O'Clock

Pipe Height: (in.) Direct  
Pipe Material: **Clay** ☐ Pipe Lined  
Invert Depth: **5.85** (ft.) Flow Characteristics: **None**  
Deposits: ☒ **None** ☐ Mud ☐ Sludge ☐ Debris ☐ Grease  
Silt Depth: (in.) Deposits Extent:  
Infiltration: **None** Pipe Seal Cond: **Sound**

Connects To: **Stub connection / abandoned**
